Whakapaupakihi 5 **File: 18/67/2**

Whakapaupakihi 5 : Lease Inspection and Valuation Report

LEASE INSPECTION REPORT

Whakapaupakihi No. 5 block

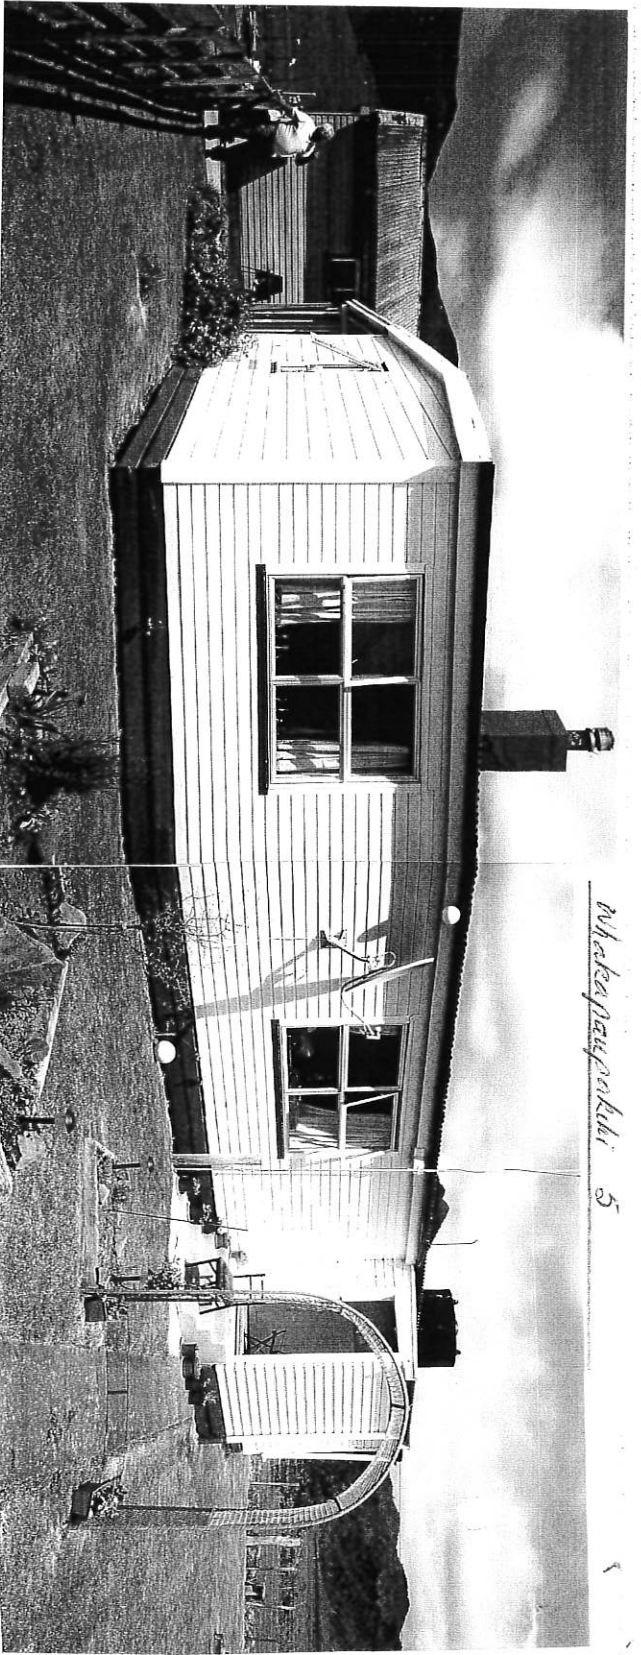
The front (north) side of the house which is basically sound and well painted but needs minor repairs

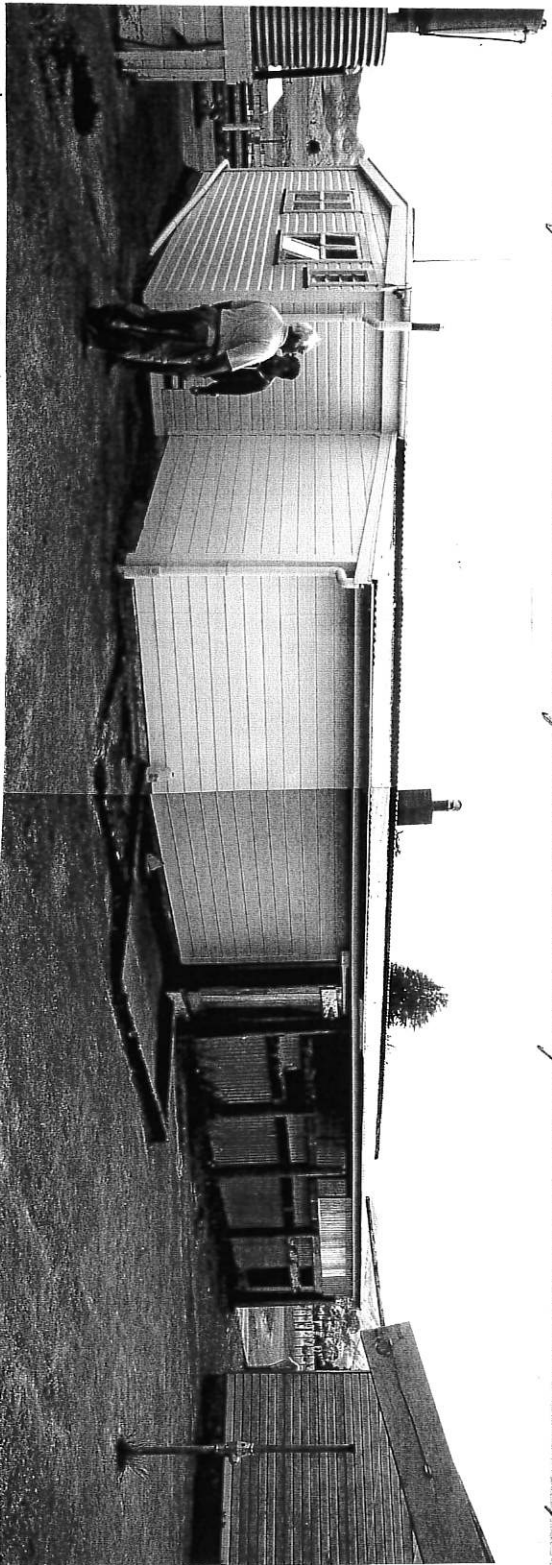
The back (south) side of the house showing the covered carport.

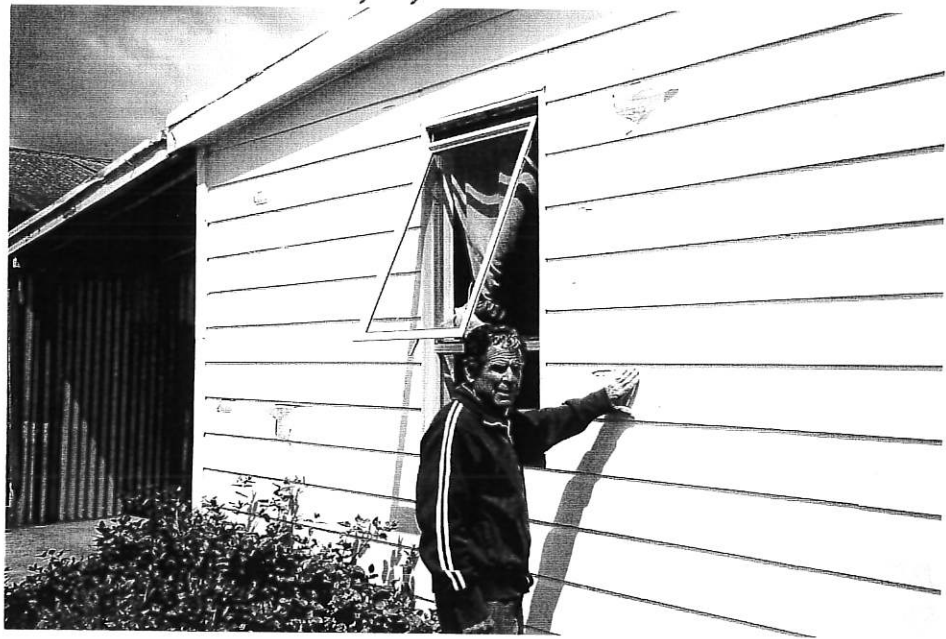
Paint on the east side of the house is flaking off. (No undercoat on the primer)

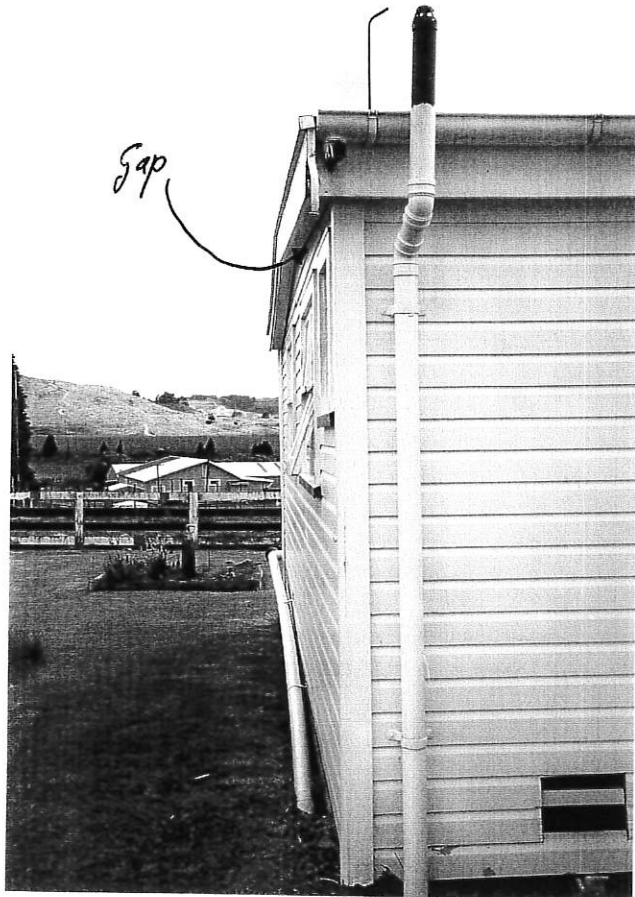
An open area under the gable barge board needs sealing. The ceiling lining inside is rotting.

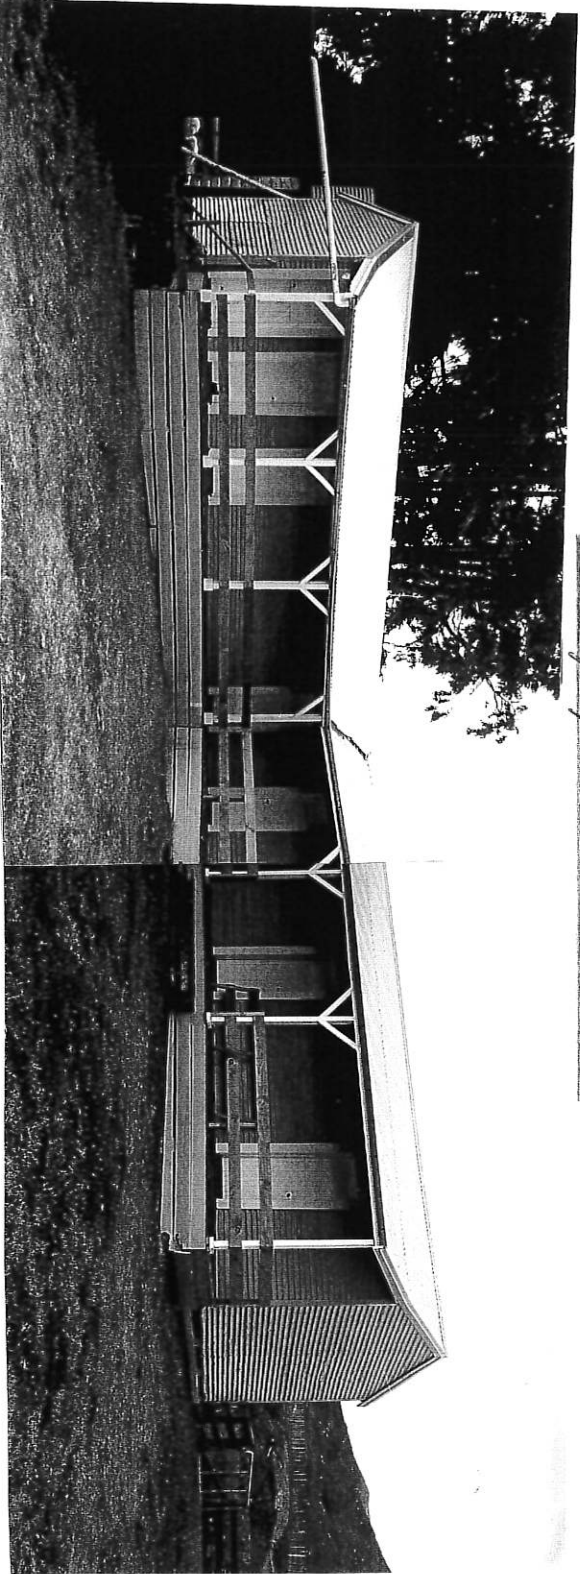
The Steamer Quarters is well painted and heavily secured but needs some minor repairs - see other photos.

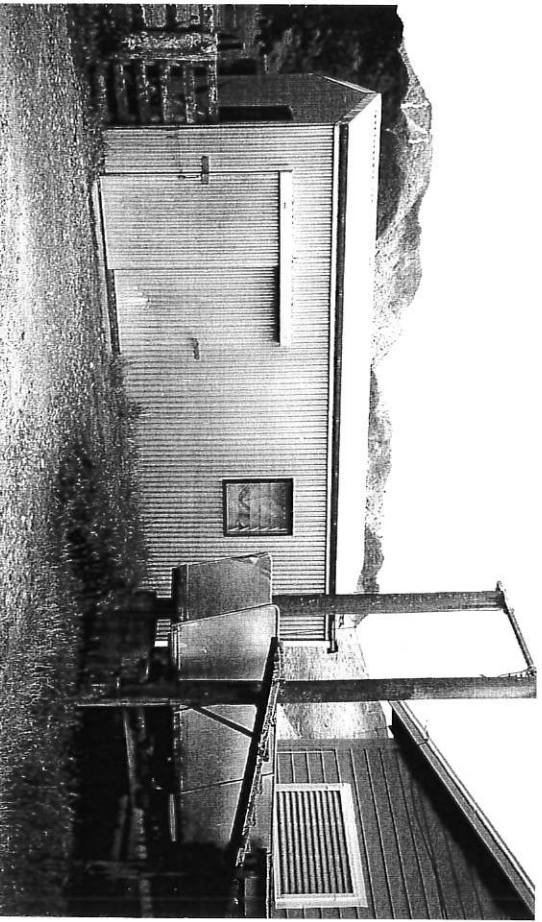
The Billing house at the wharfhead is in good order

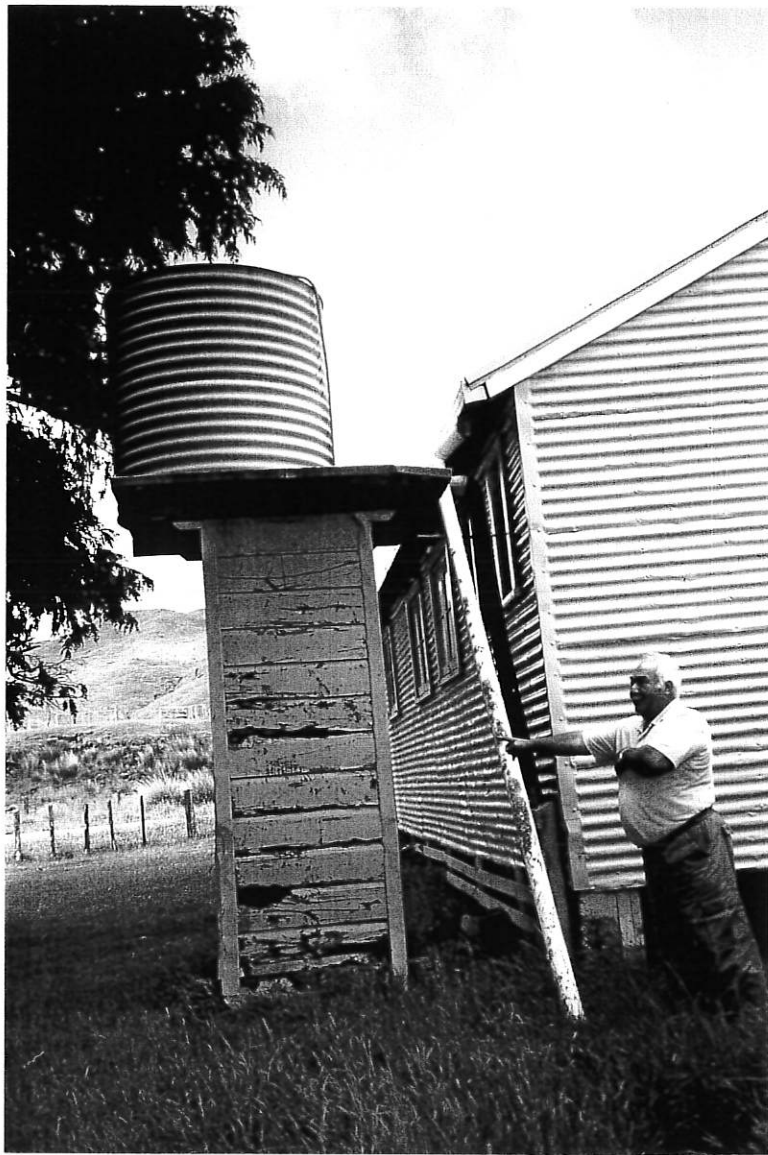
Trustee Russell showing the water tank stand which needs rebuilding

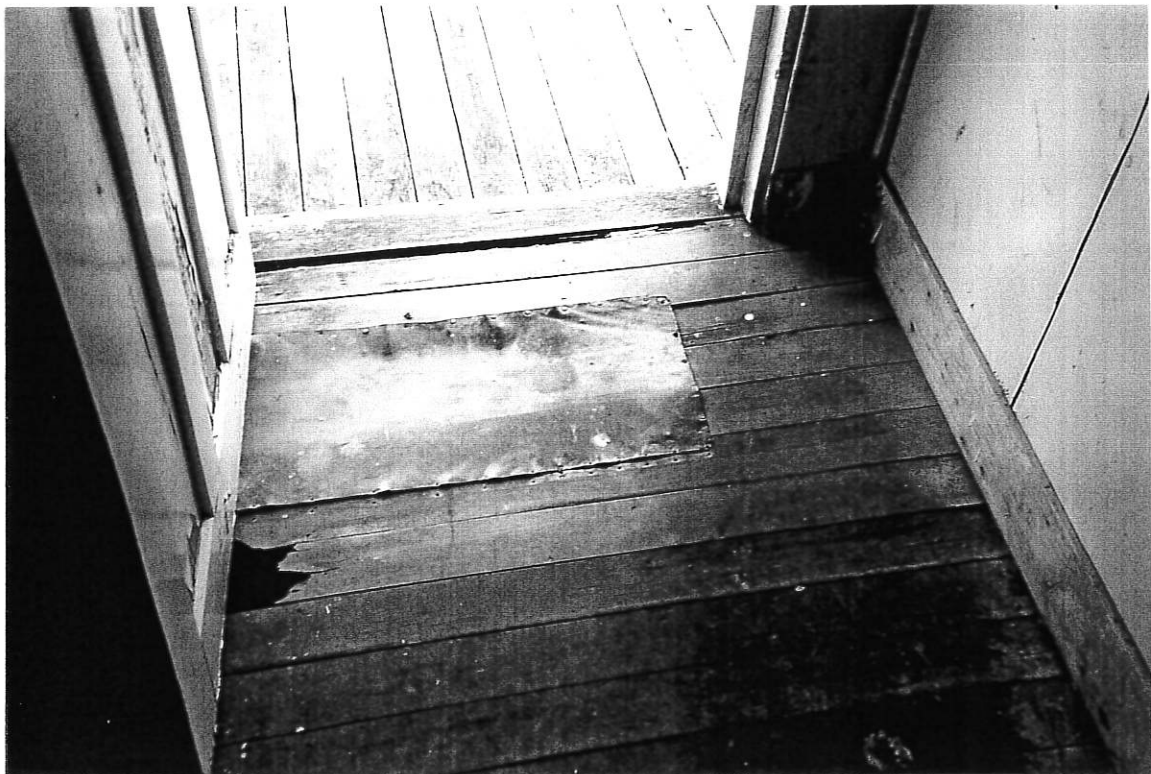
is part of the Shearer Quarters floor needs replacing EGH 12/04

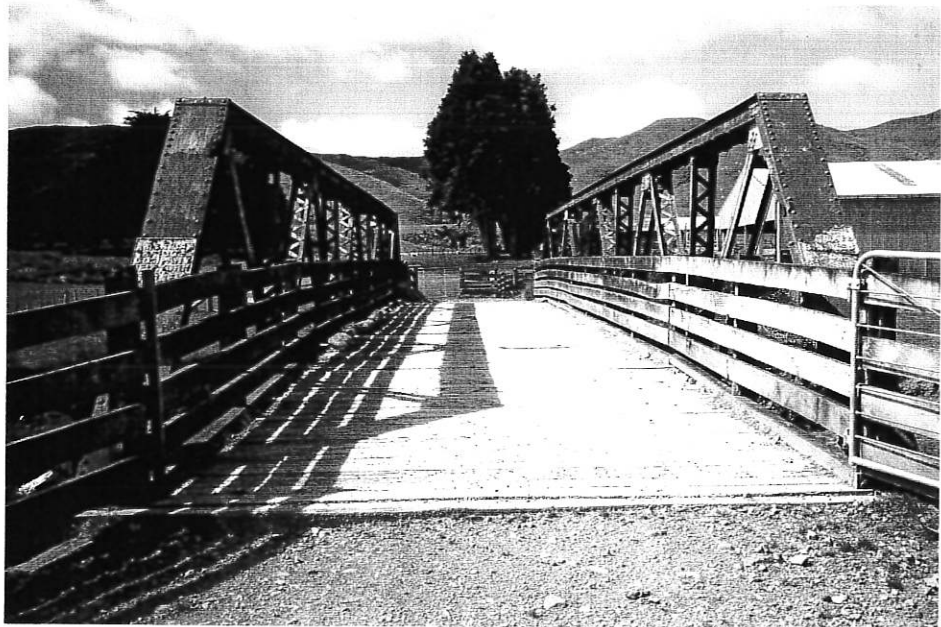
The bridge actually crosses the Motukere Stream on Section 6. The basic structure is very old but appears sound and adequate for farm use.

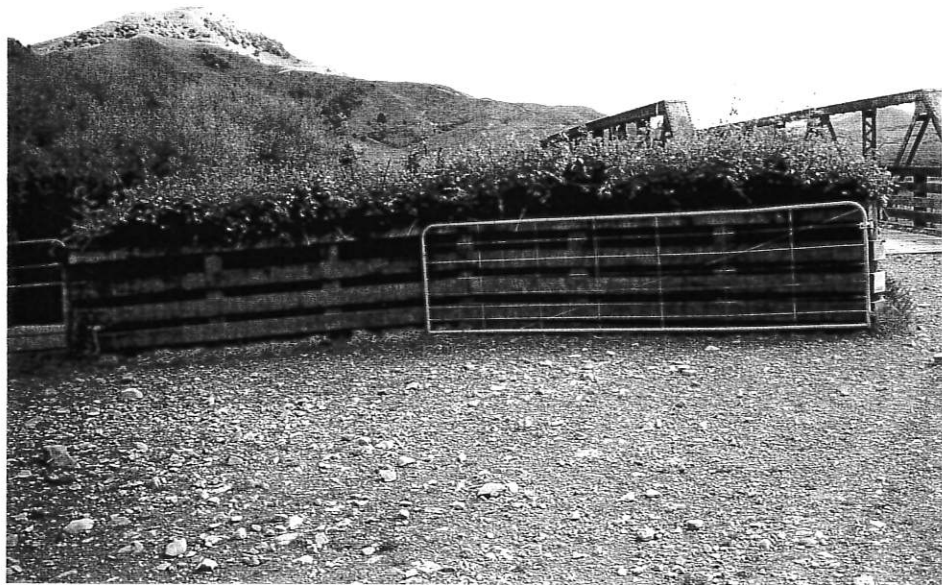
More blackberry near the bridge - needs spraying and eradicating.

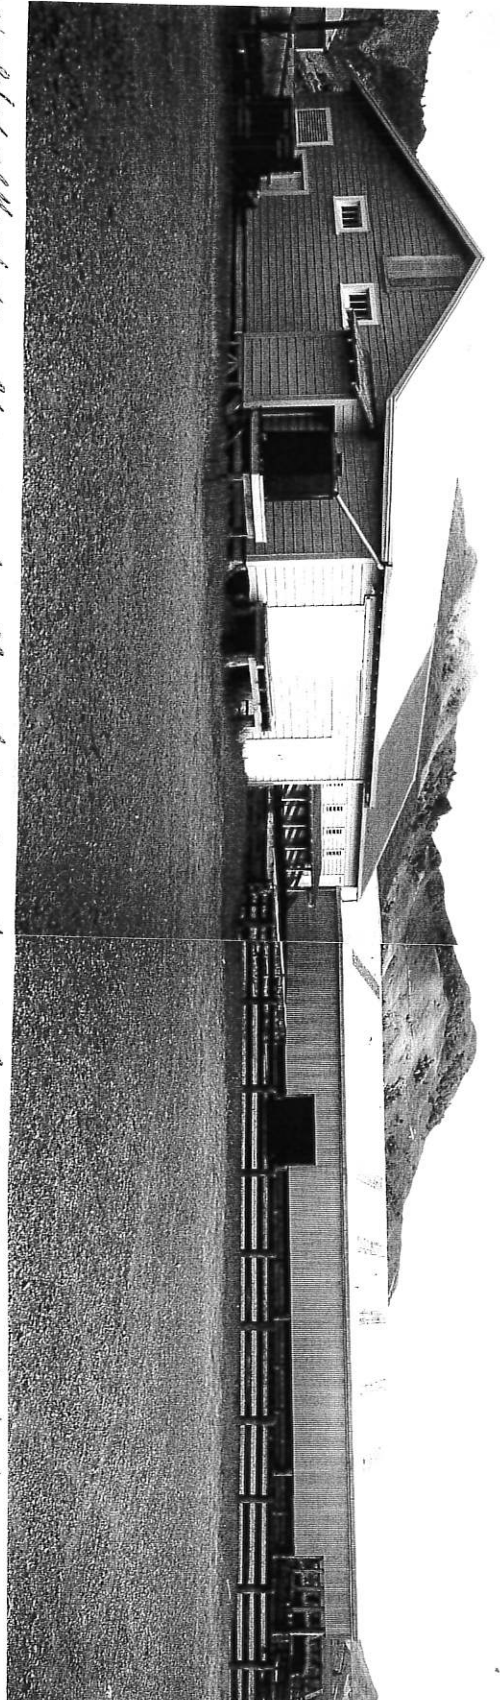
The weathered although very old is sound, well painted and maintained. Covered yards are at right.

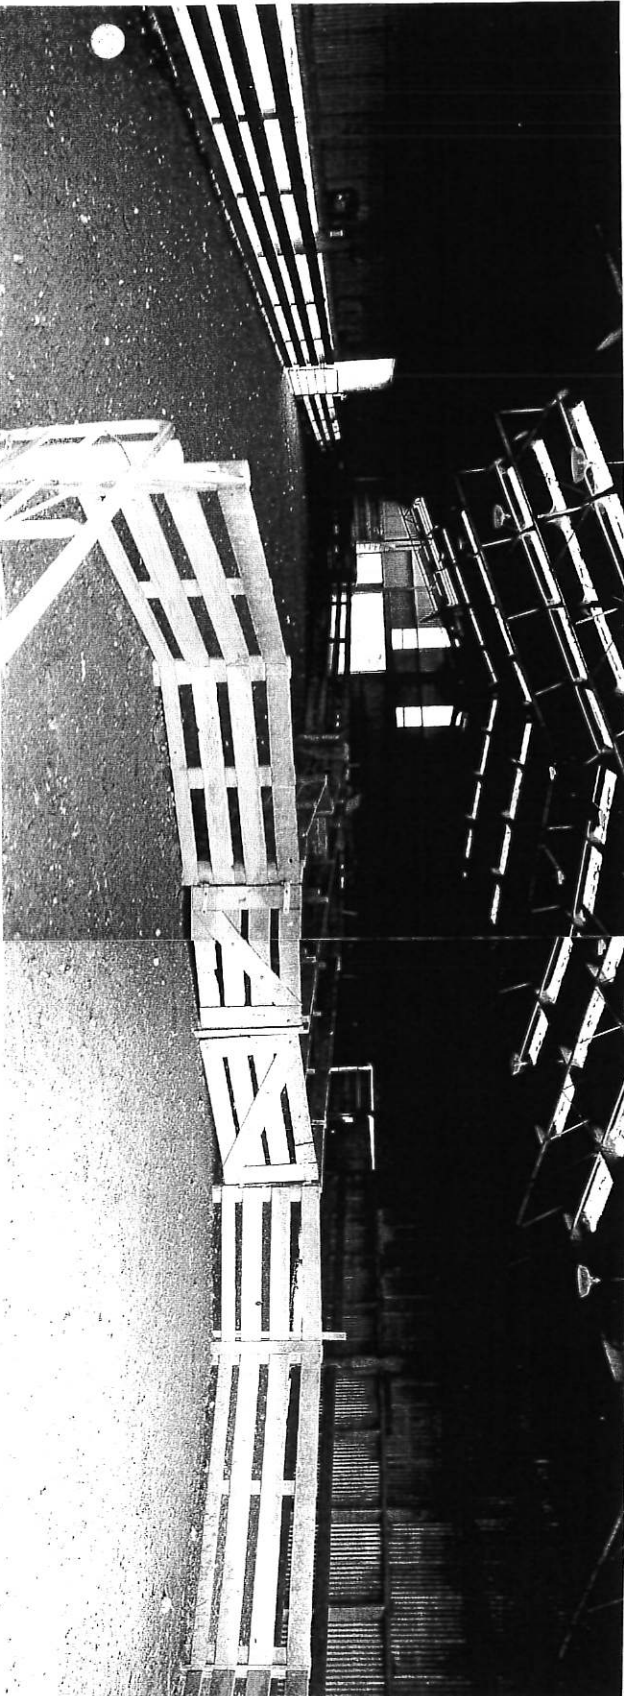
Inside the covered yards which is relatively new. All in excellent order.

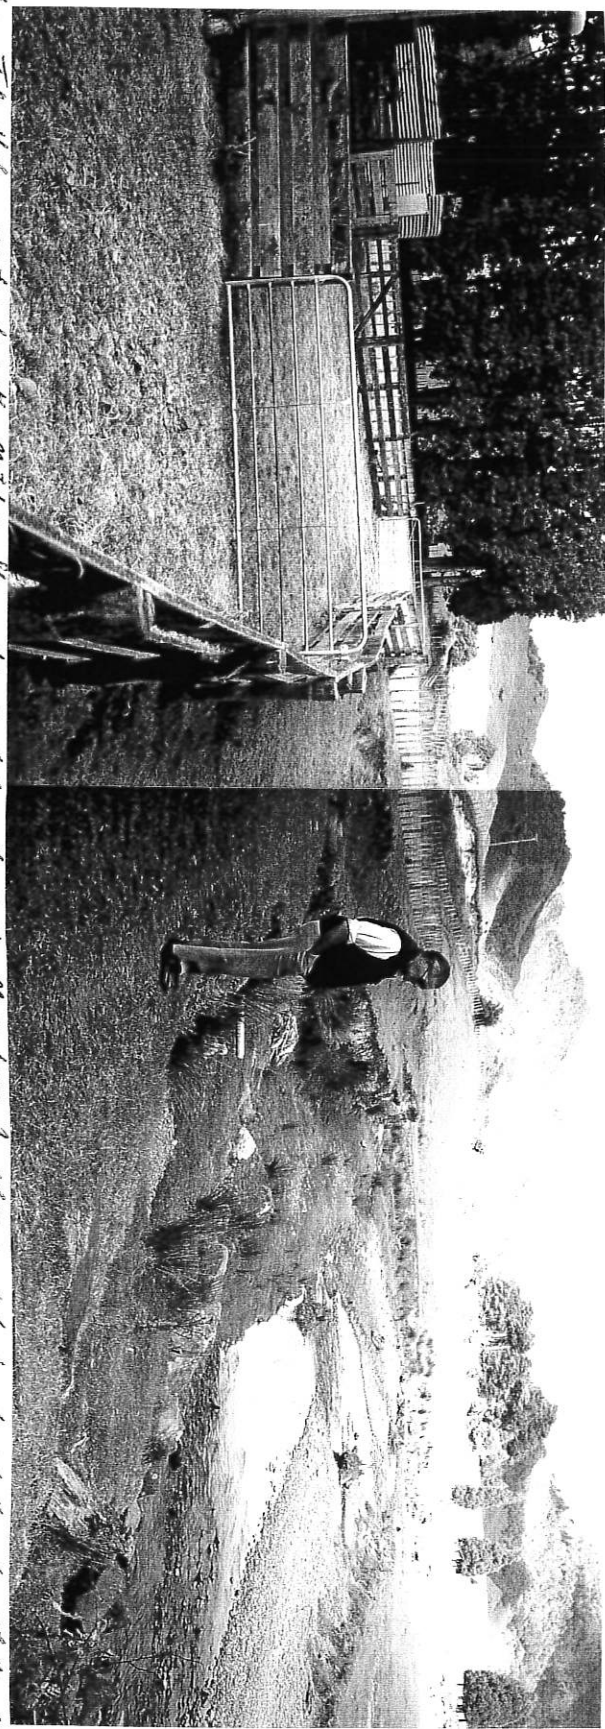
Trapper John Hays suggests where the Northern Stream trap existed in the past. More large boulders need to be placed here to protect weirs.

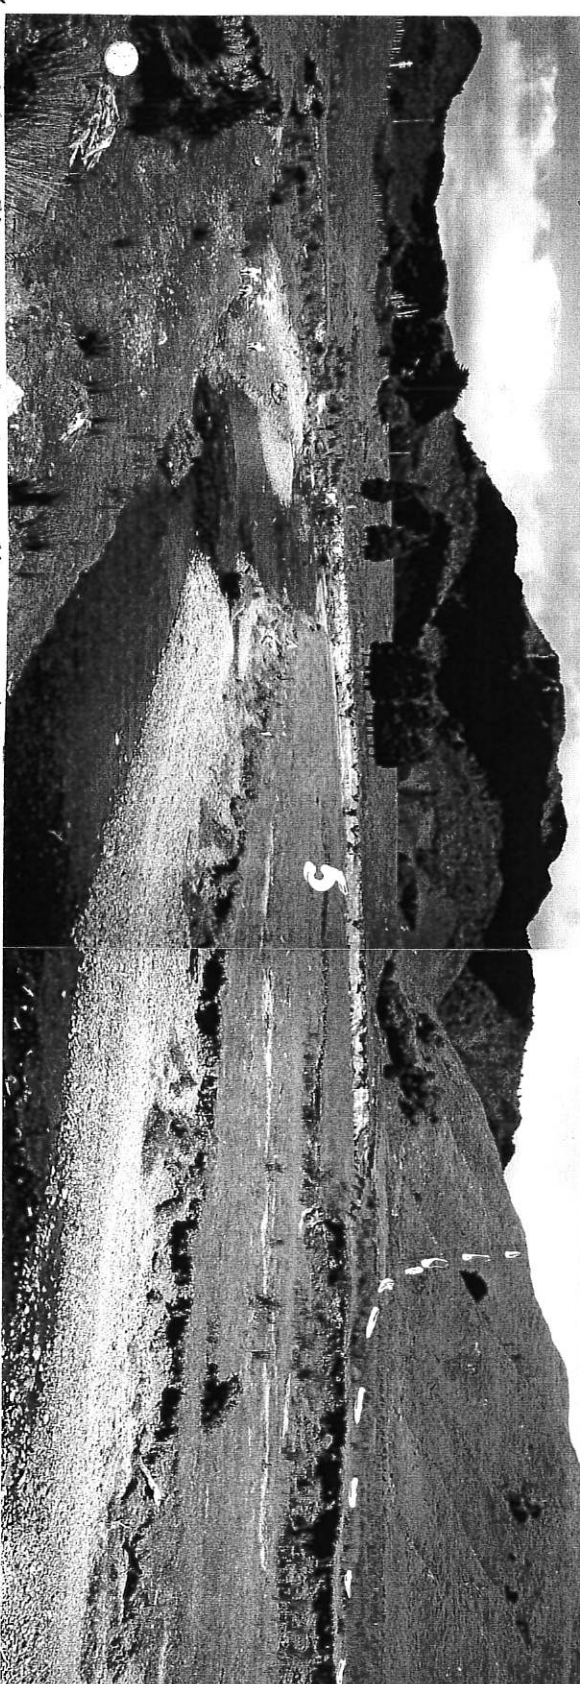
The Northern Stream is stable in the photo but is capable of eroding the banks when flooding. EGB: yfor

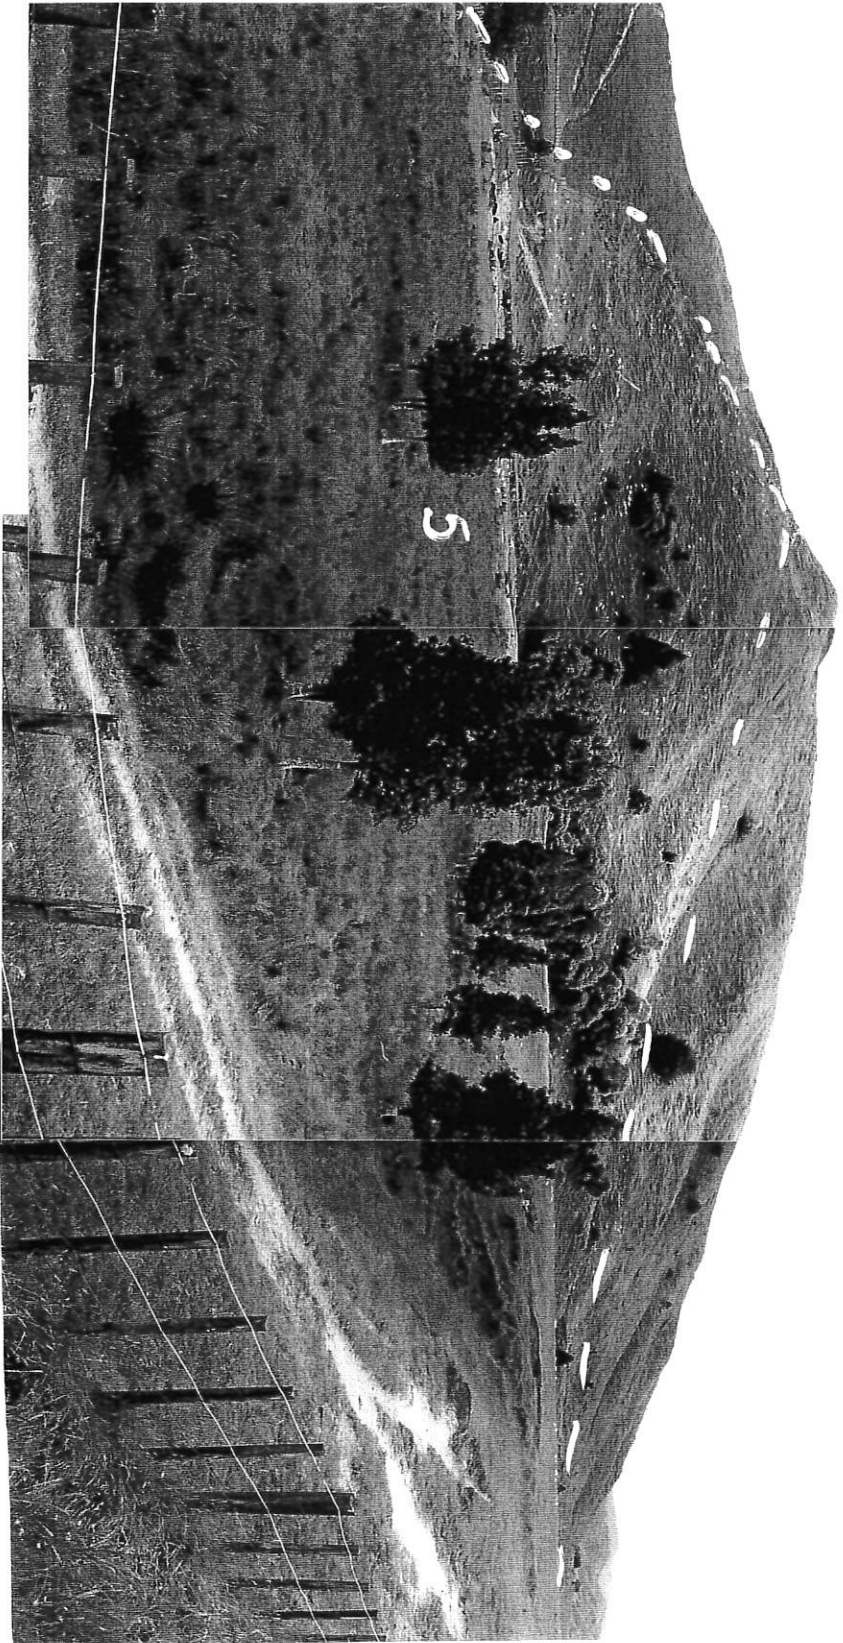
The northernmost corner of the section. There is a grave cut take boundary at left (see plan)

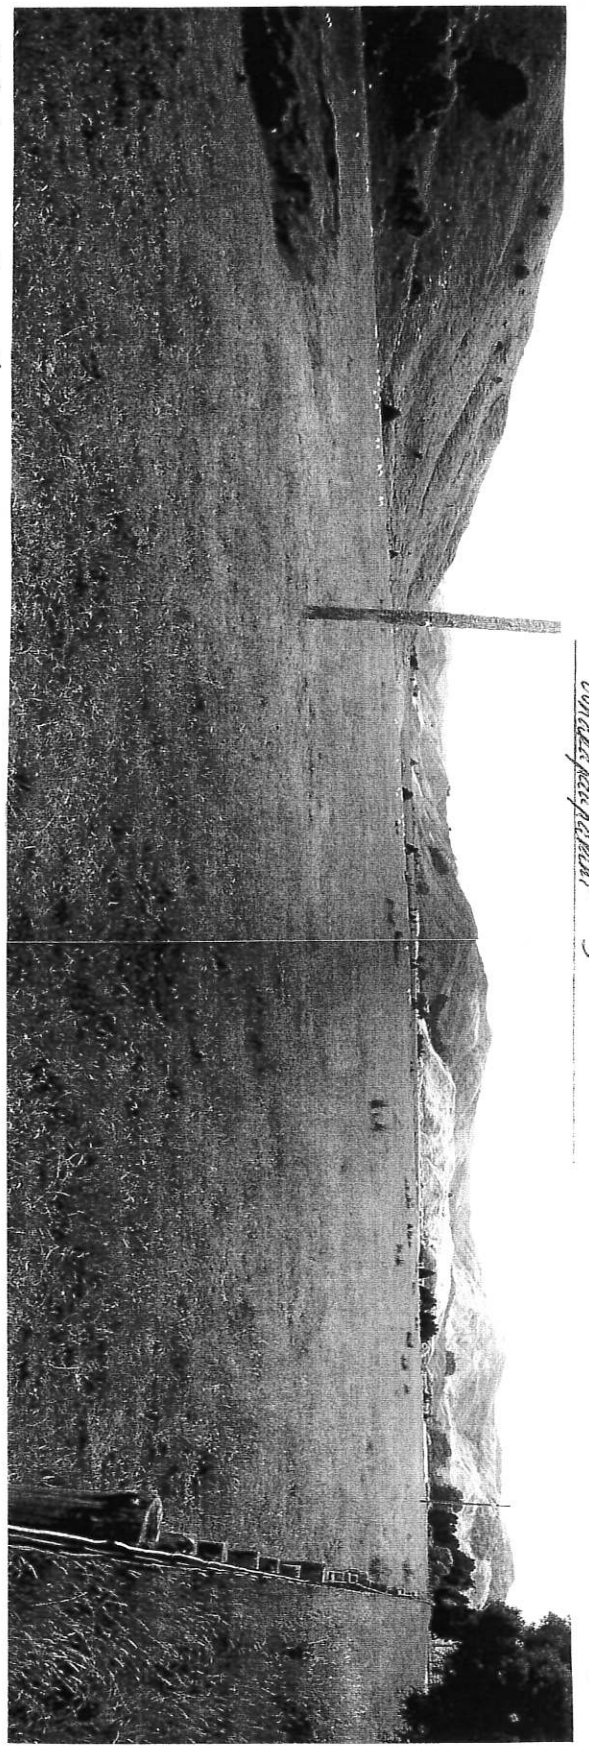
Flat land north of the road is an average pasture

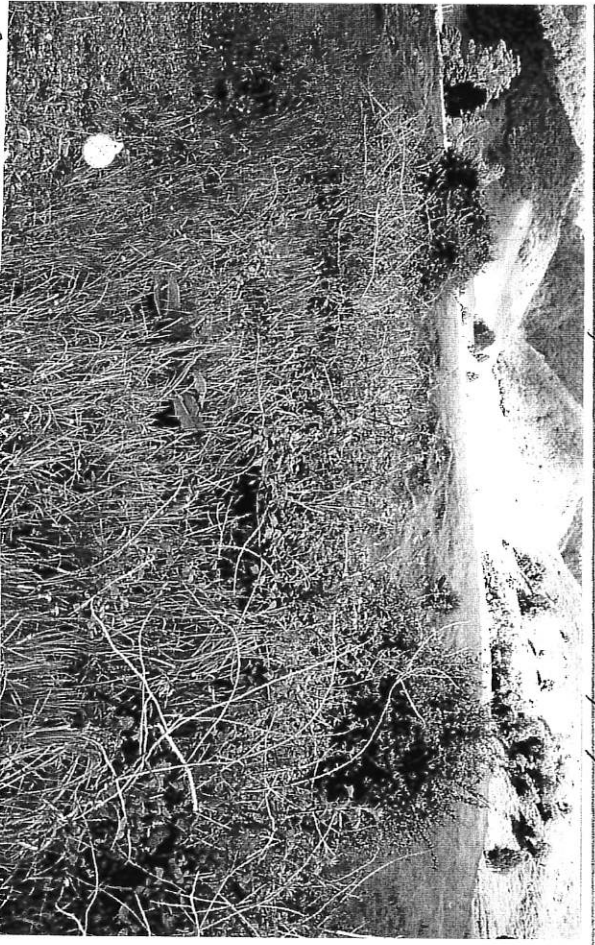
Blackberry along the road just north of highway.

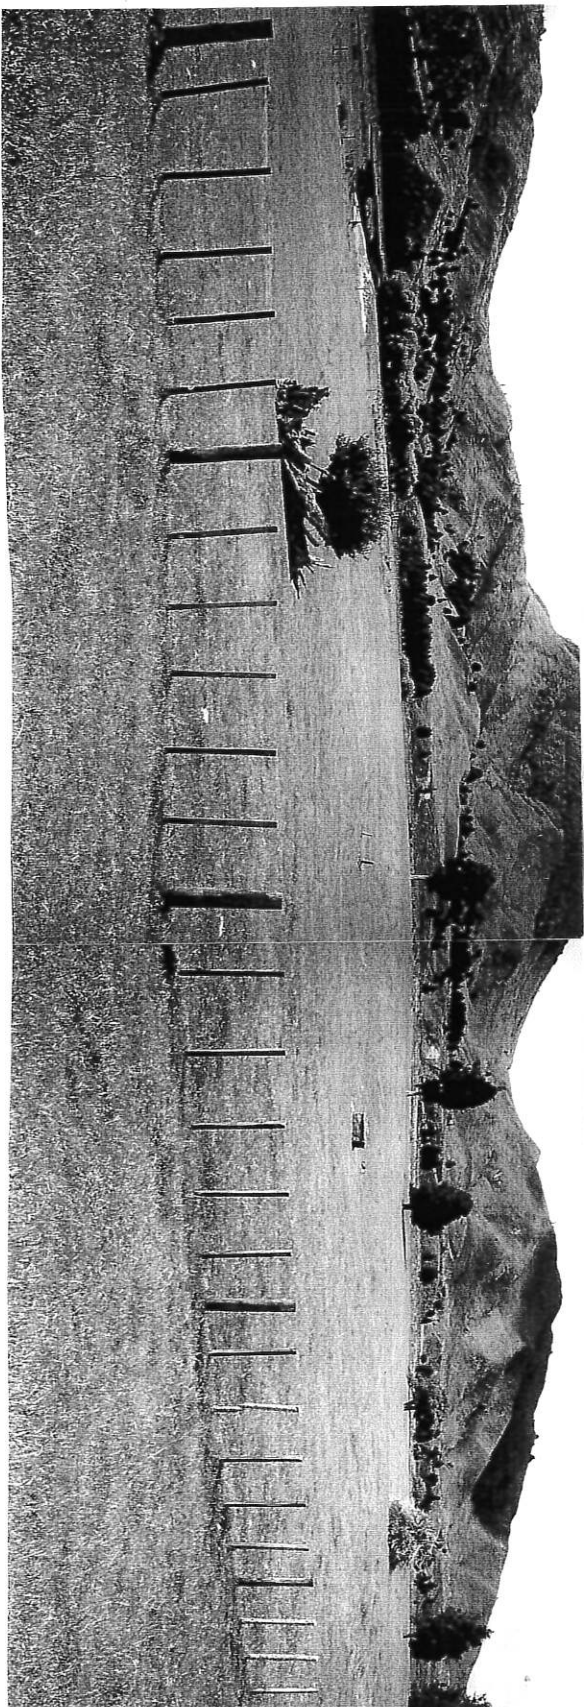
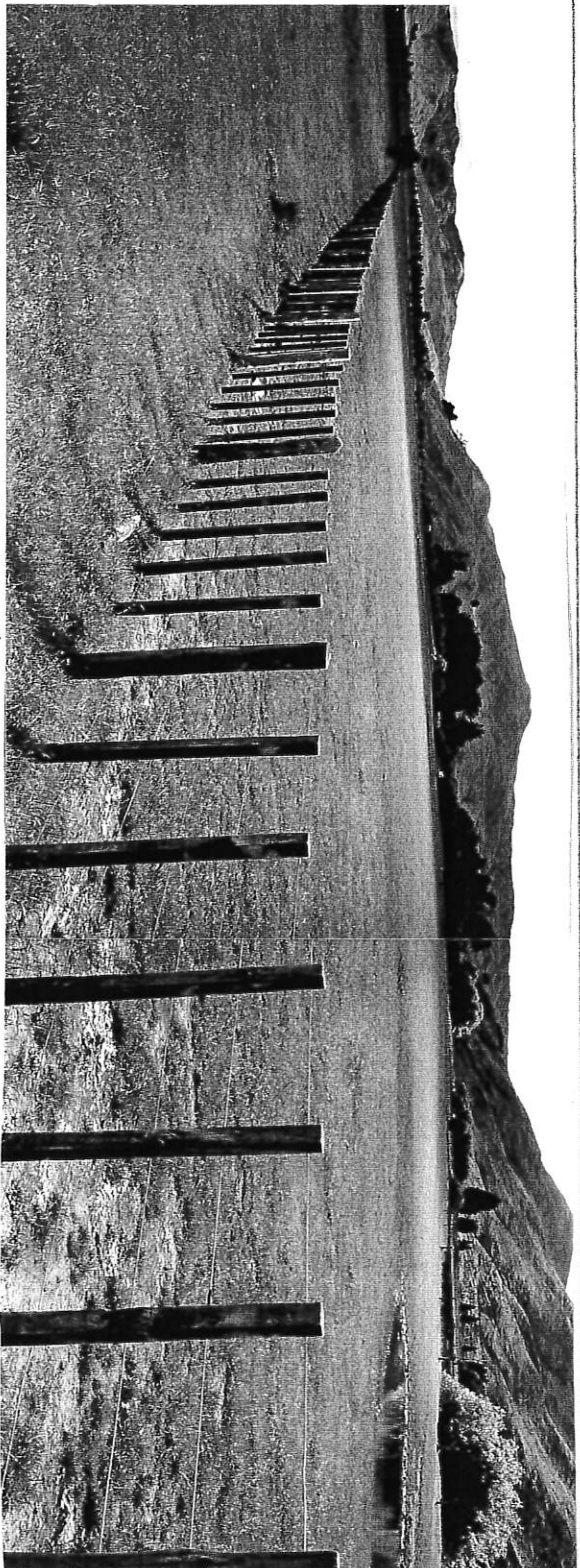
Flat land between the Mota River and the old Railway Station is now in good pasture and well fenced E.B. 12/104

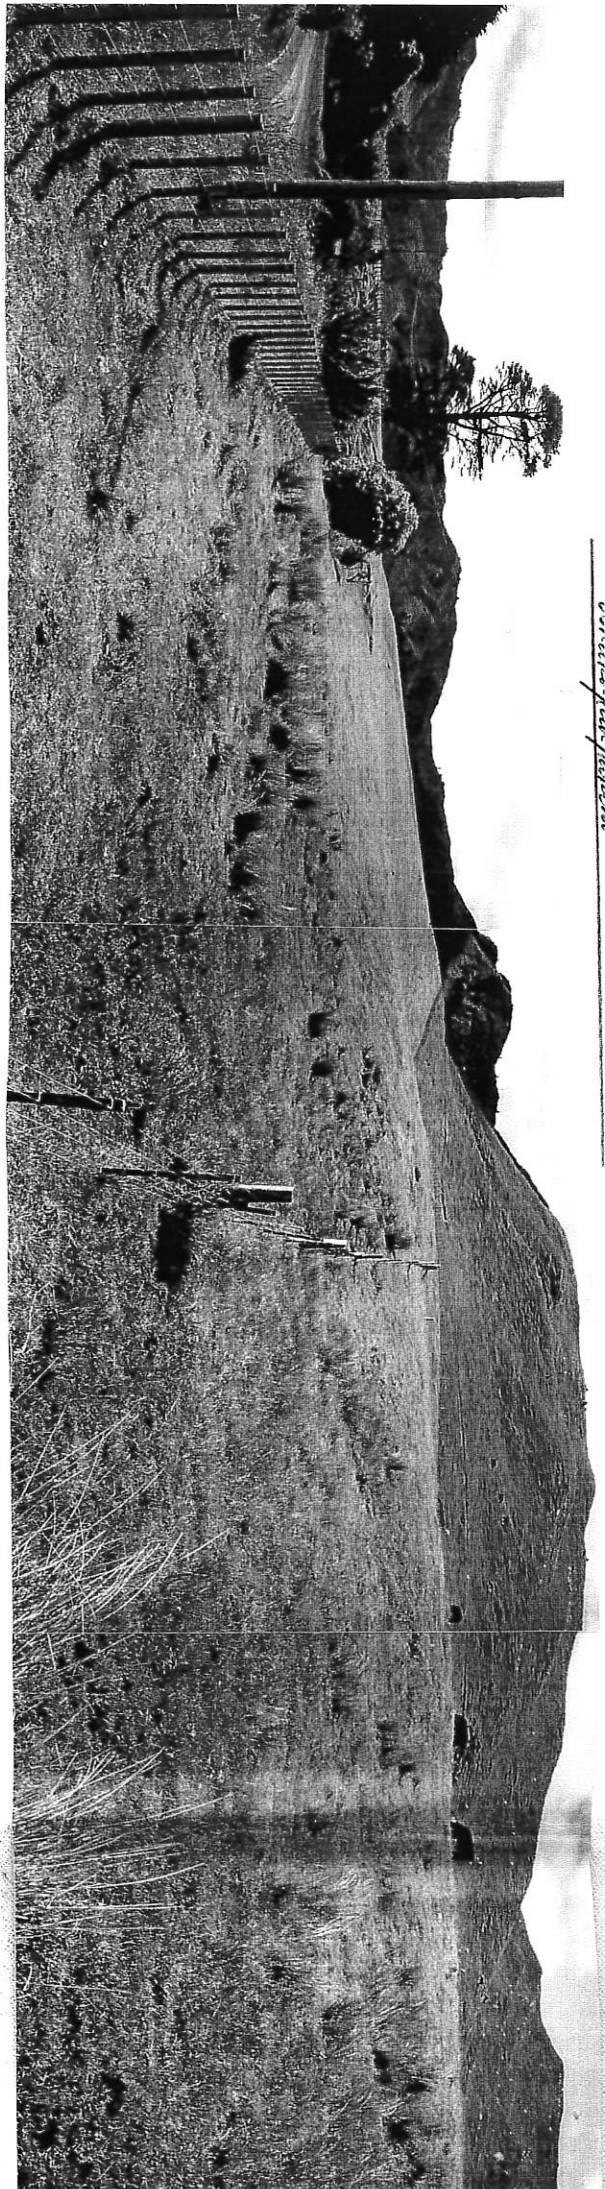
View of the easy undulating and hill south of the road. Cere is on average to good pasture

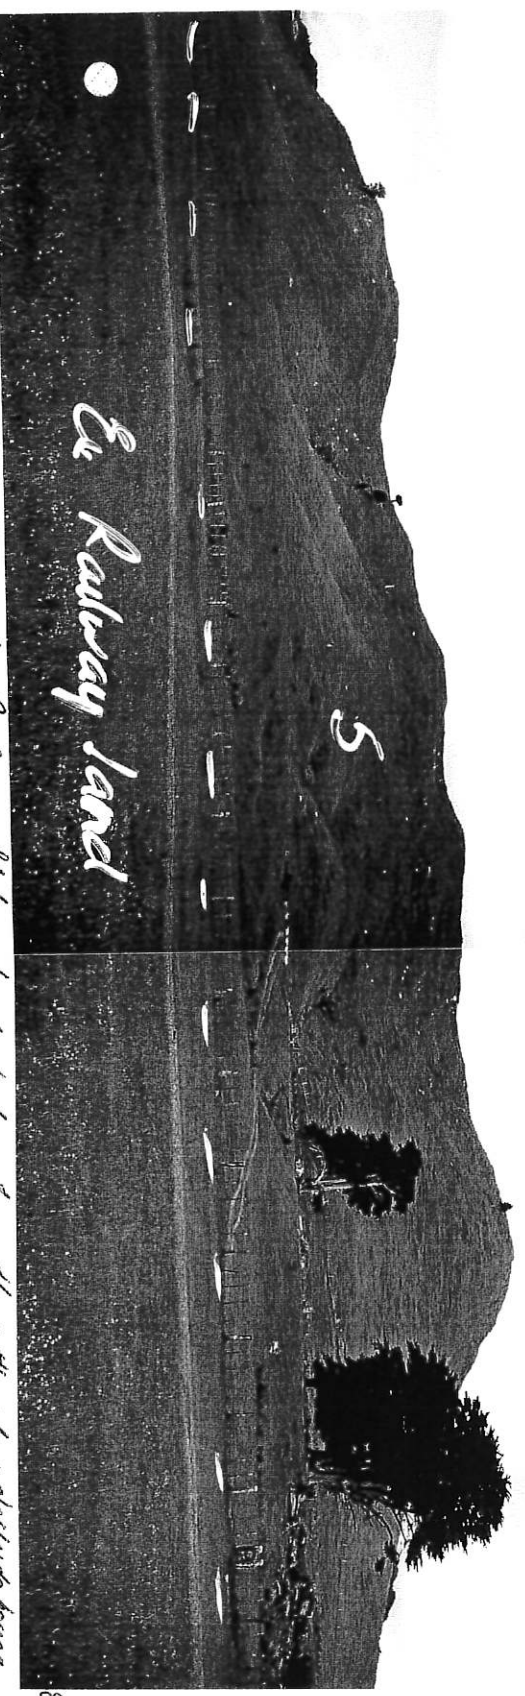
View of the hill above the old Motu Railway Station land which contains the cattle yab & shepherds house

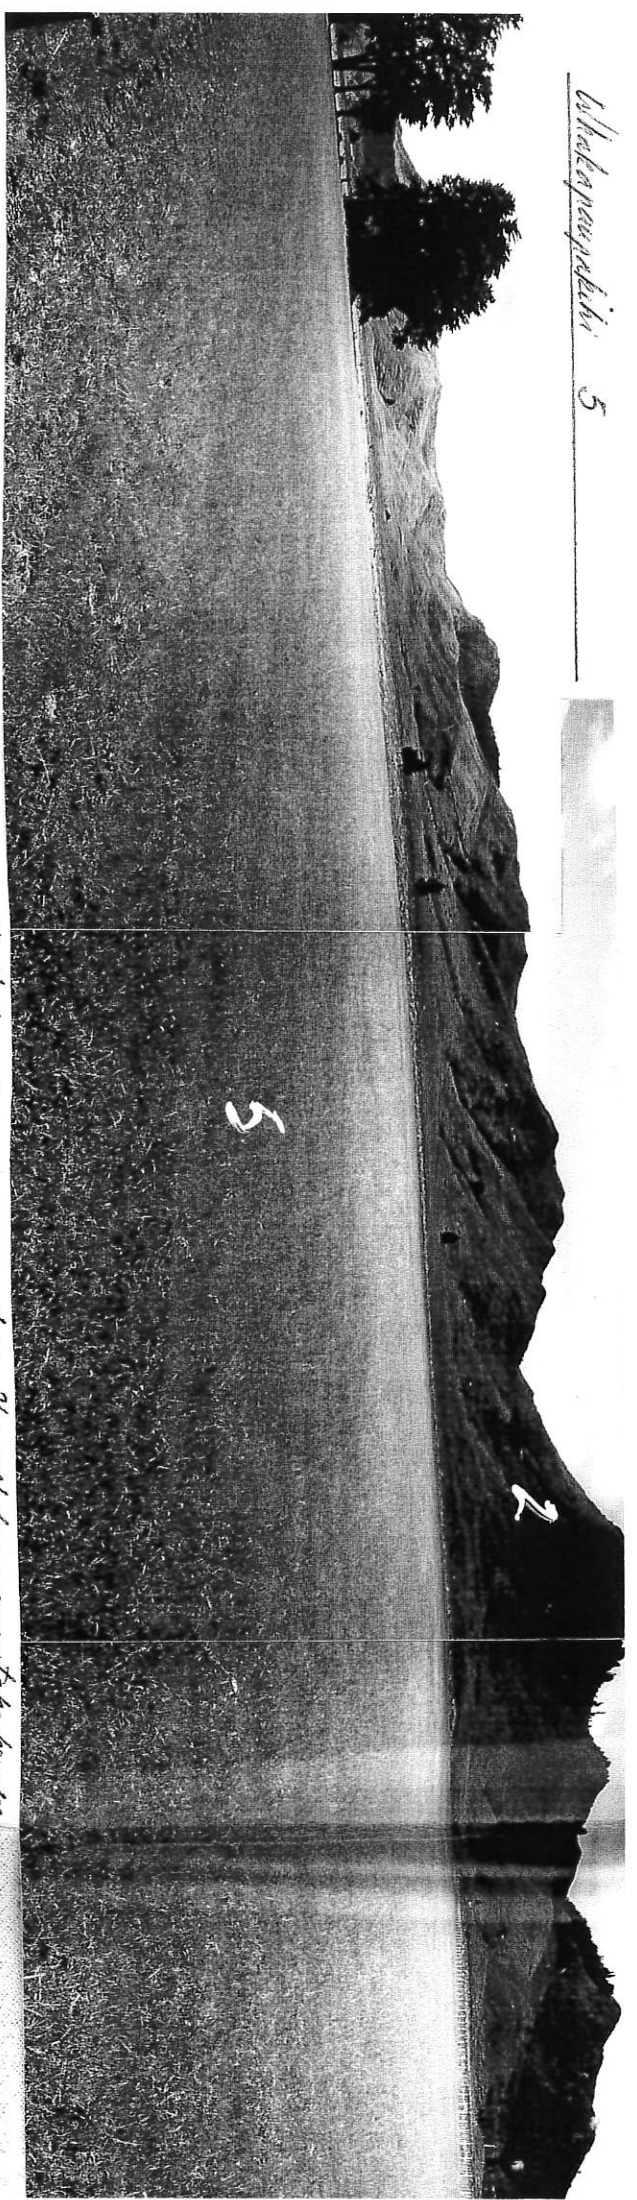
Flat land south of the road on the west end has been cultivated and sown in pasture. No path has a gate at the boundary.

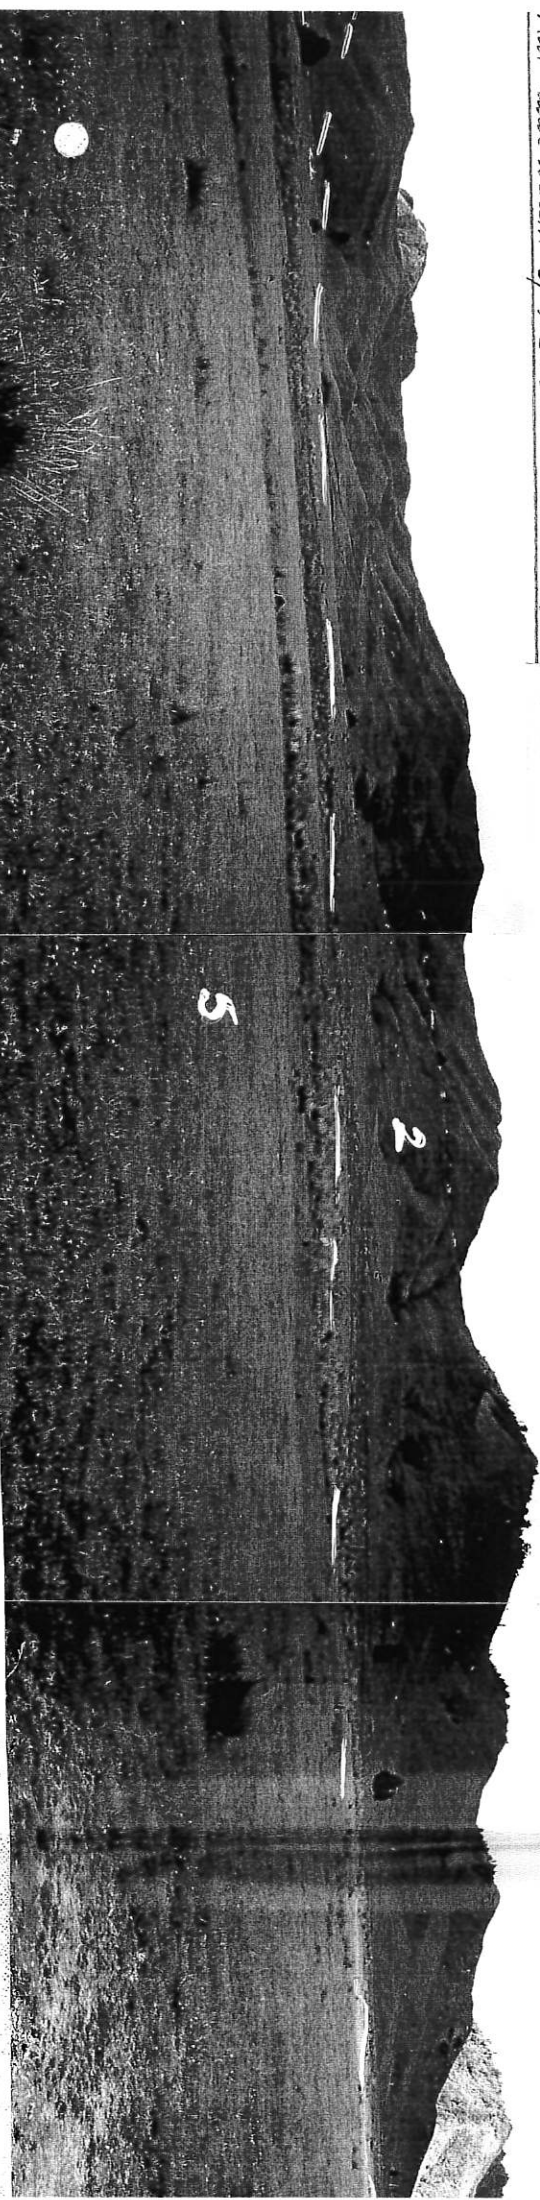
No flat area behind the site of the old hay barn also has a gate and the boundary fence (see plan) elsewhere.
