Whakapaupakihi 5 **File: 18/67/2**

Whakapaupakihi 5 : Lease Inspection and Valuation Report

LEASE INSPECTION REPORT

Whakapaupakihi No. 5 block

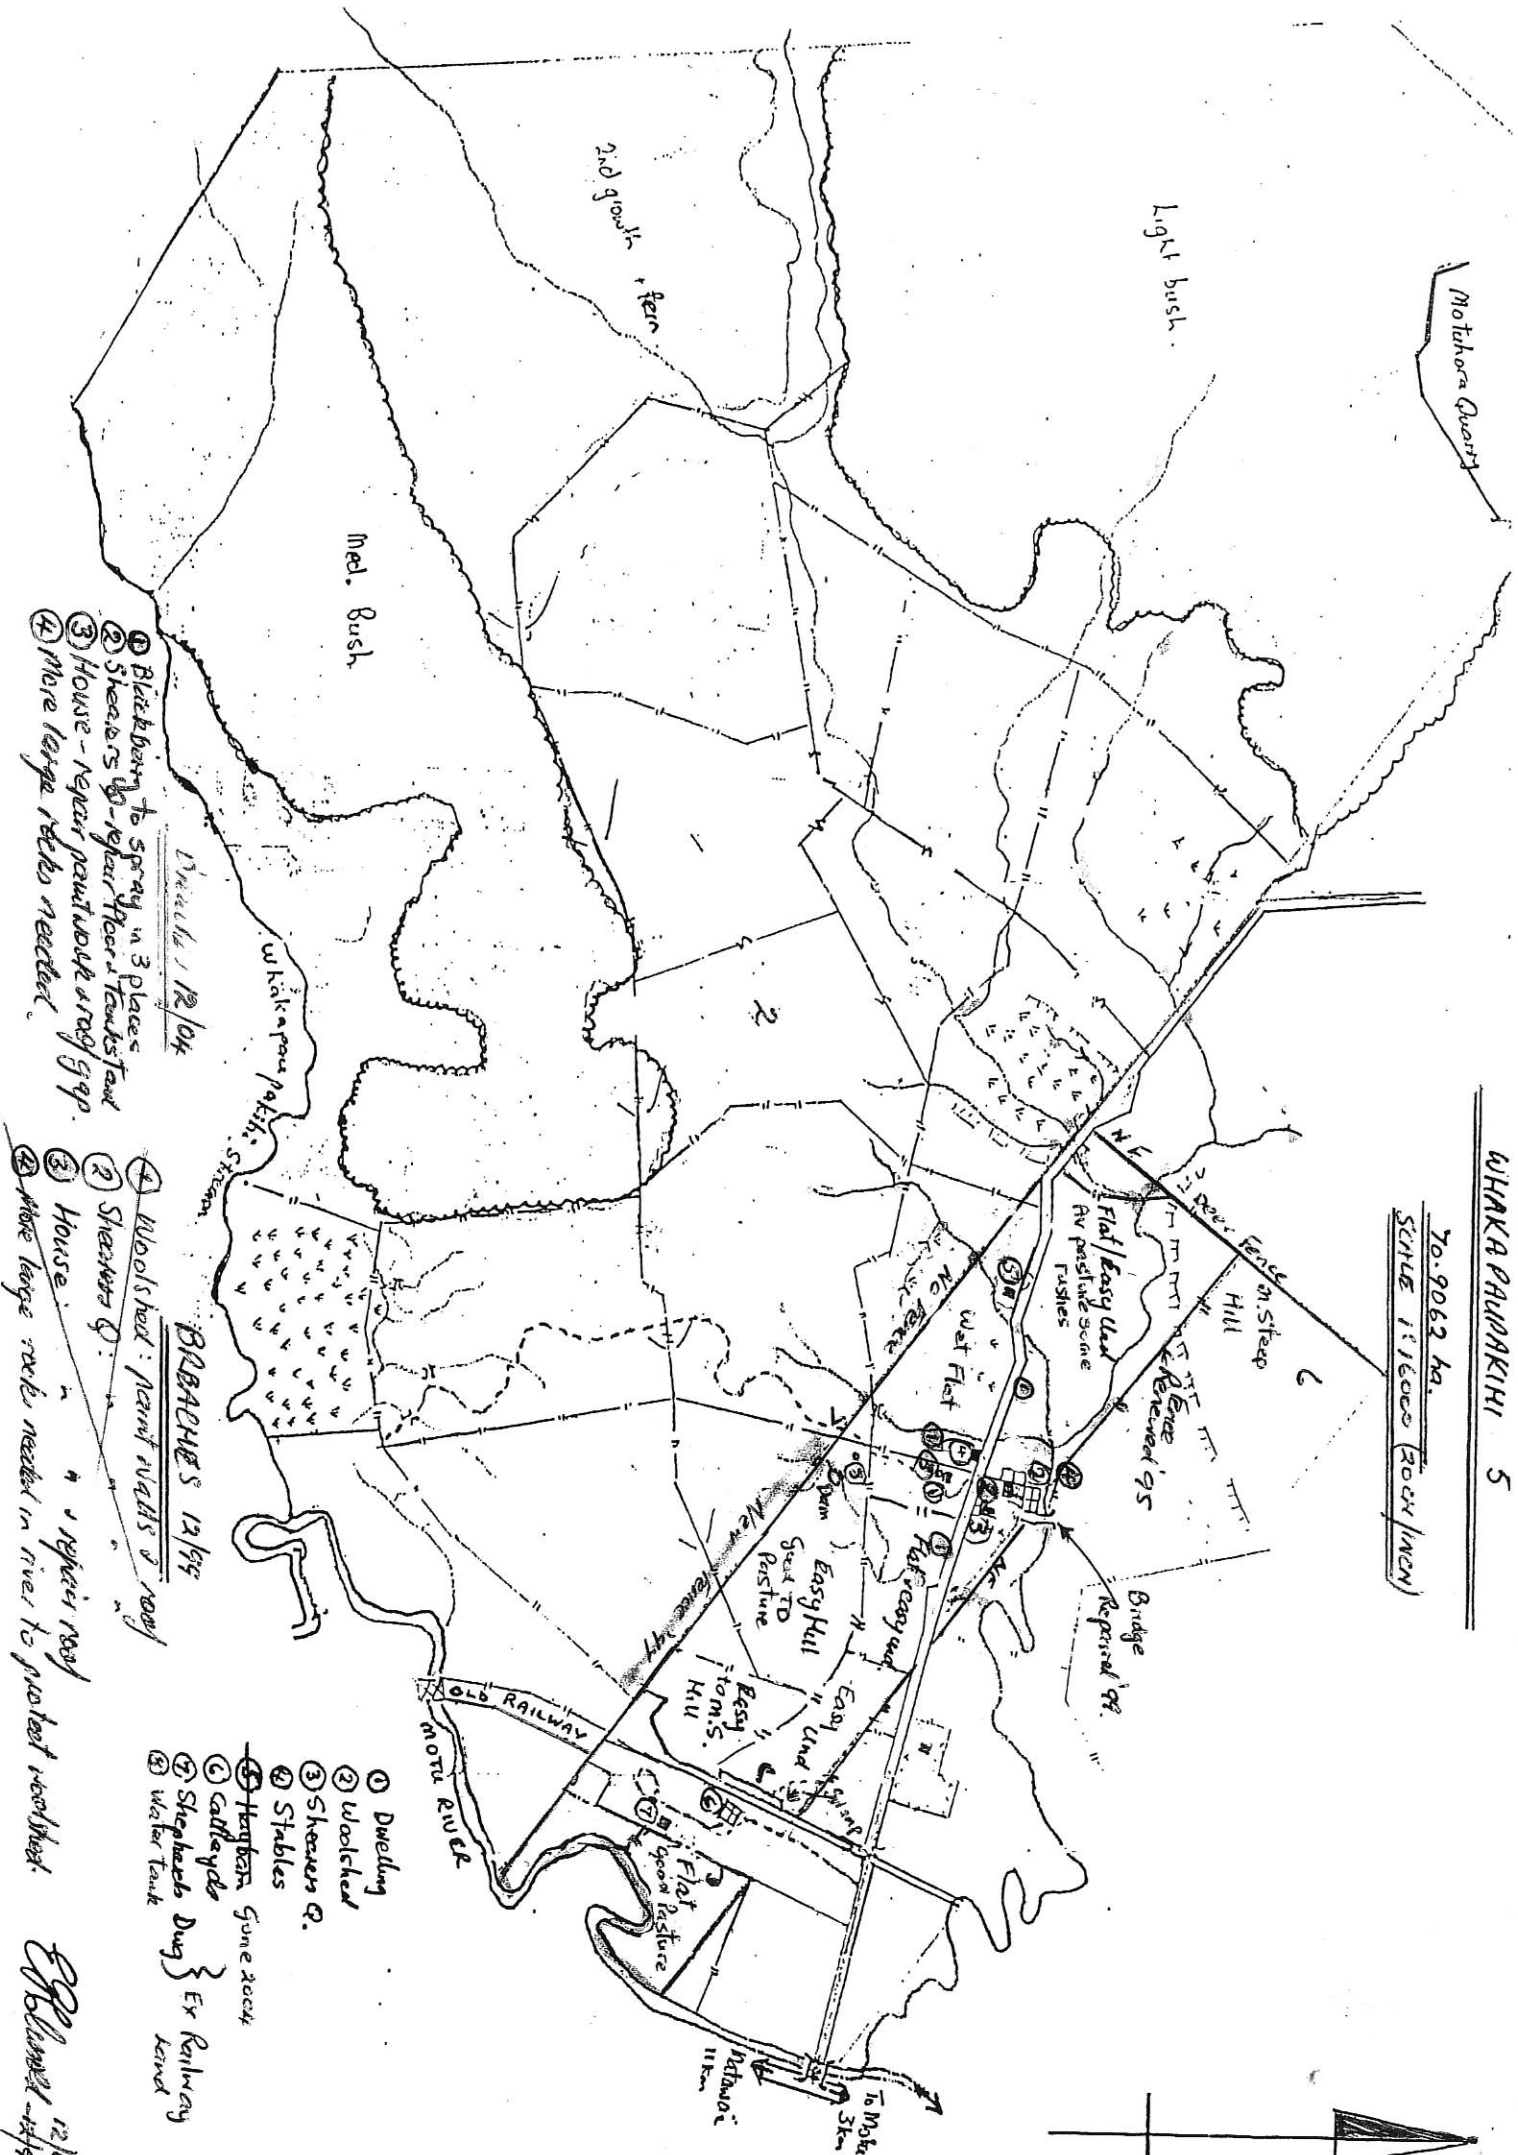
WĪHAKA PAUPAKIHI 5

- ① Blotchberry to spray in 3 places
- ② Shearers to repair shearers foot
- ③ House - repair paint about a roof gap
- ④ More large rocks needed

- ① Woolshed - repair walls & roof
- ② Shearers Q.
- ③ House - repair roof
- ④ More large rocks needed in river to protect weathervane

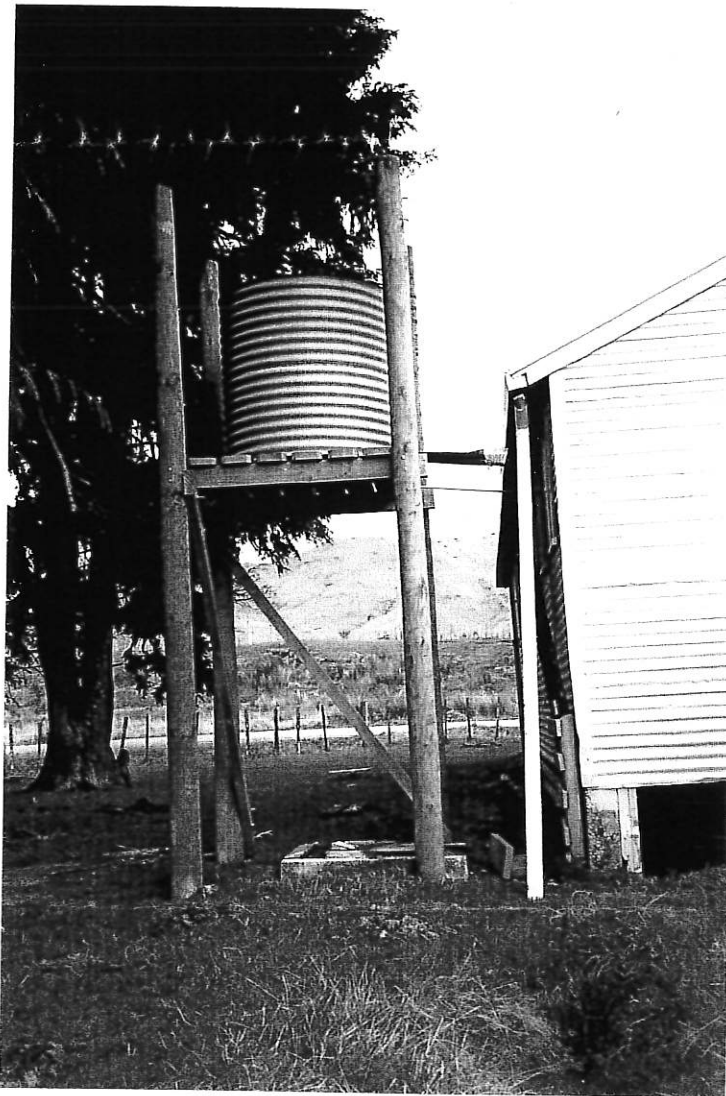
The tankstand behind the shearer's quarters has been rebuilt to a good standard.

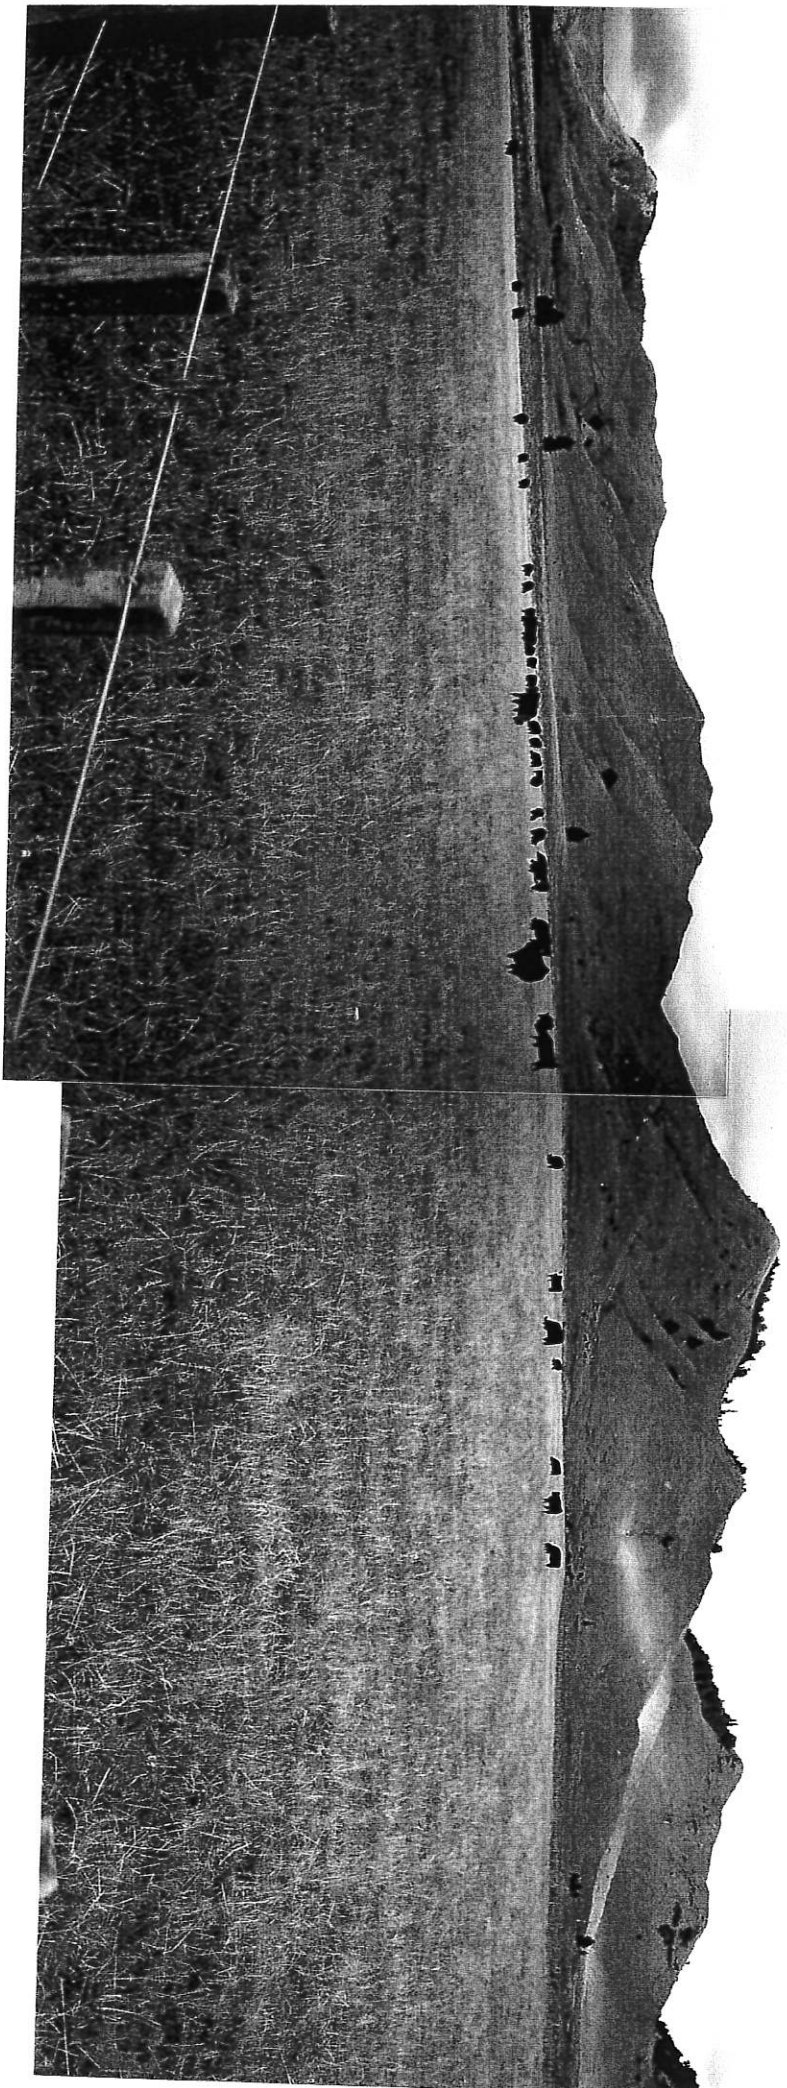
An attempt was made to open cutover in this paddock in 2004/2005 by Four Seasons (Barnett, ^{John})
Apparently the crop was not successful and it was poorly situated before sowing
in new pasture which is poor quality.

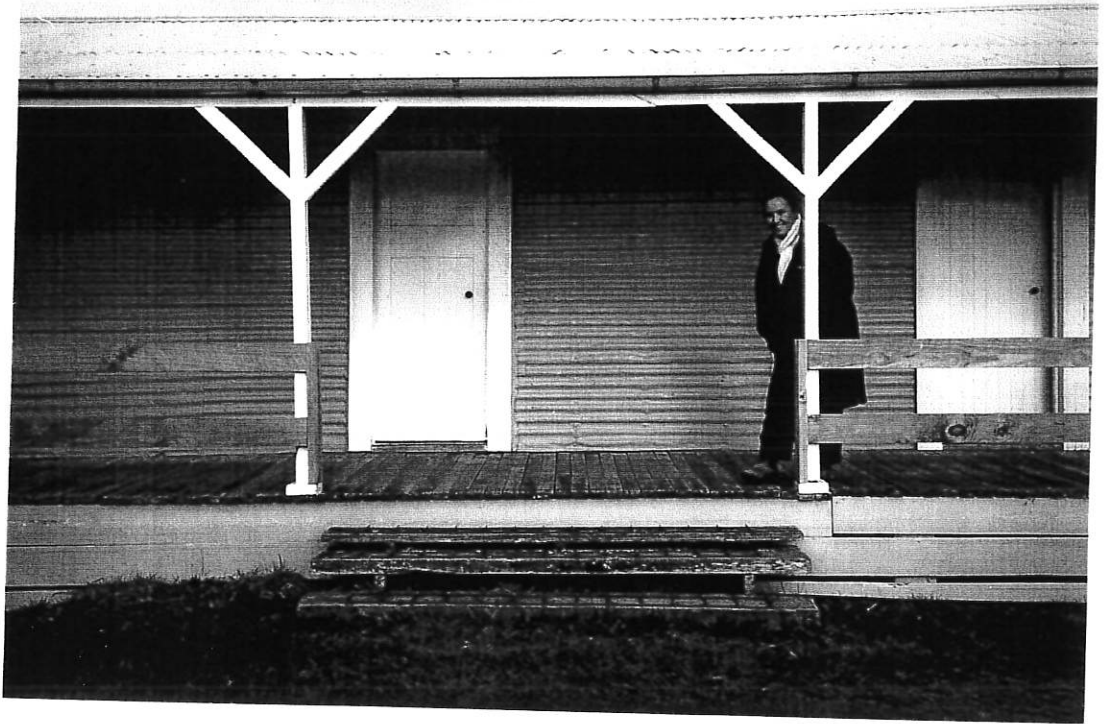
Rose Wharehanga inspecting the repaired verandah floor at the shearer's quarters.

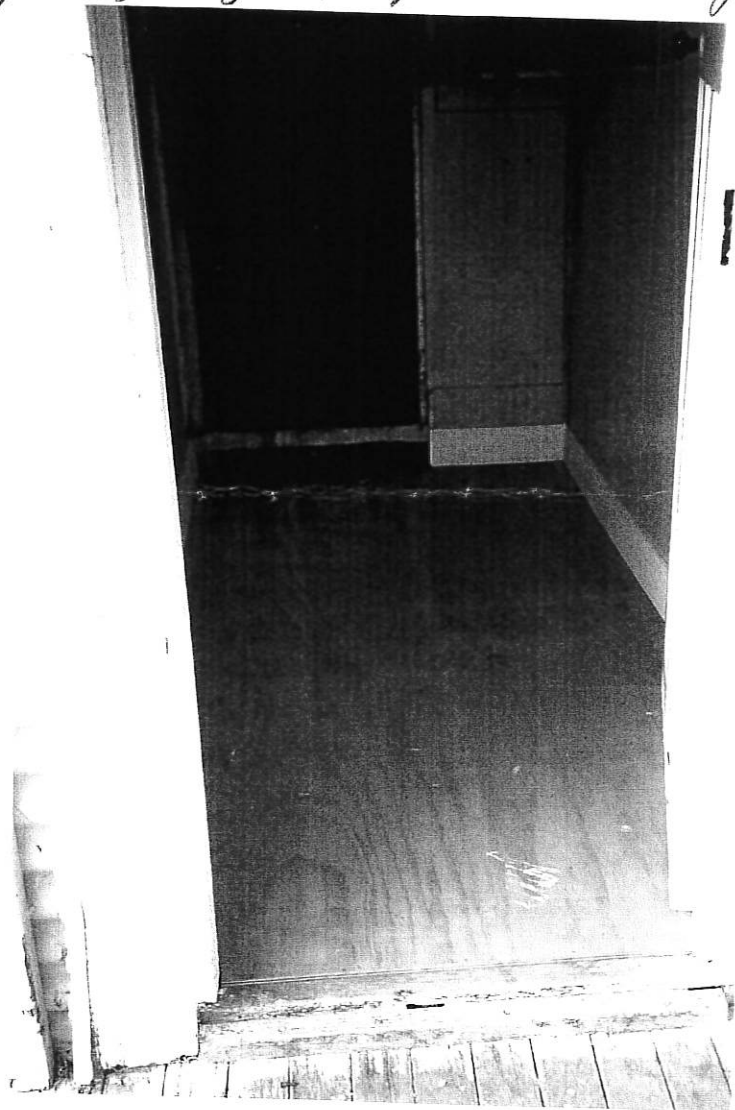
New floor replaces the rotten one in the shearer's quarters

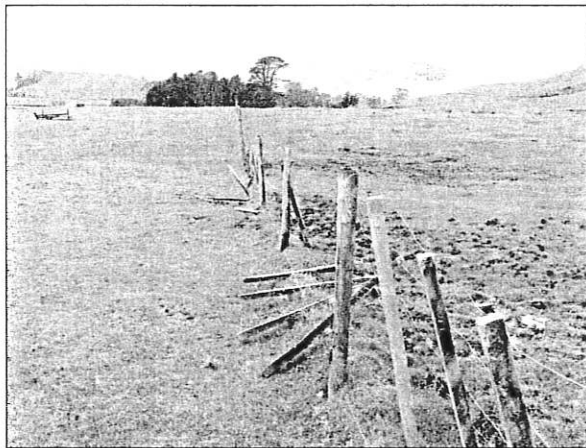
There is some damaged fencing behind the house where apparently a large plastic tank (see water) was removed off the hill this need fixing.

Fence where tank was removed

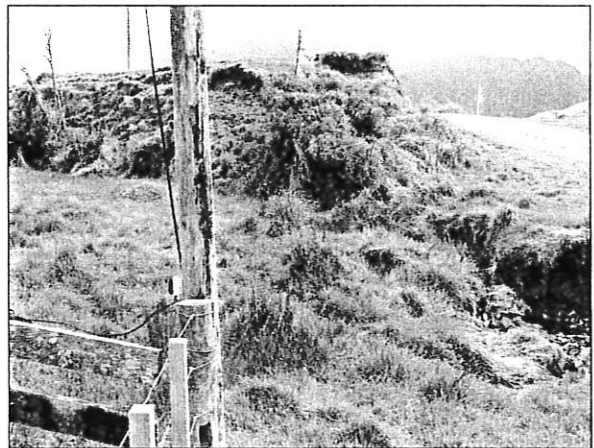
There is some road fencing that has been damaged some time ago by a storm that needs repairing (approx 14 metres need replacing).

Road fence which is not in place

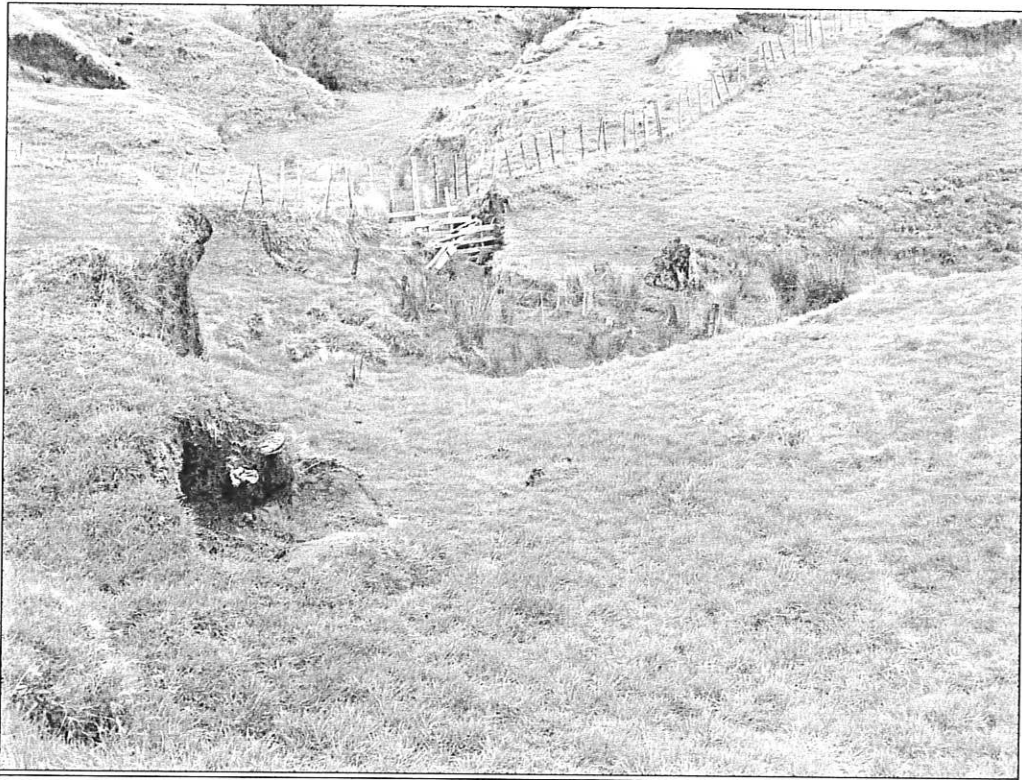
There was a stock crossing that has been washed out, which appeared to be in conjunction with the damaged road fence, behind the house.

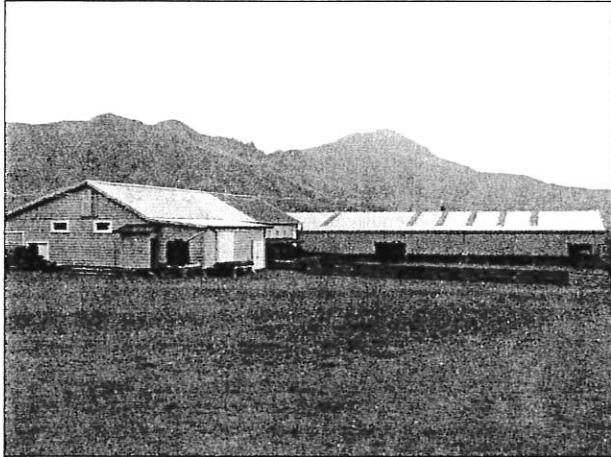
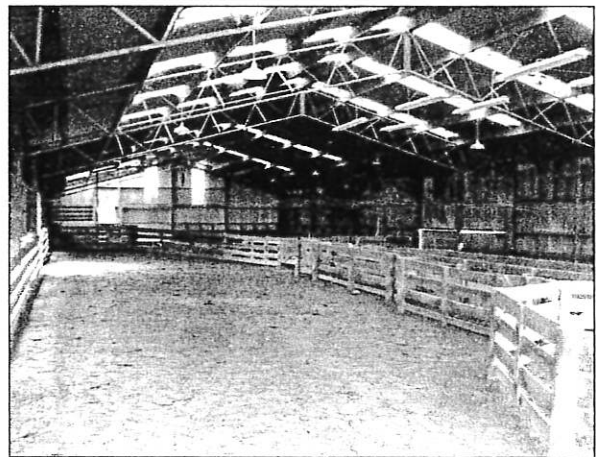
Woolshed

A large 8 stand wool shed with a large covered yard complex in generally very good condition.

There is no shearing plant in the shed and this would be a problem if the shed was a going concern at the inception of the lease with the previous lessee.

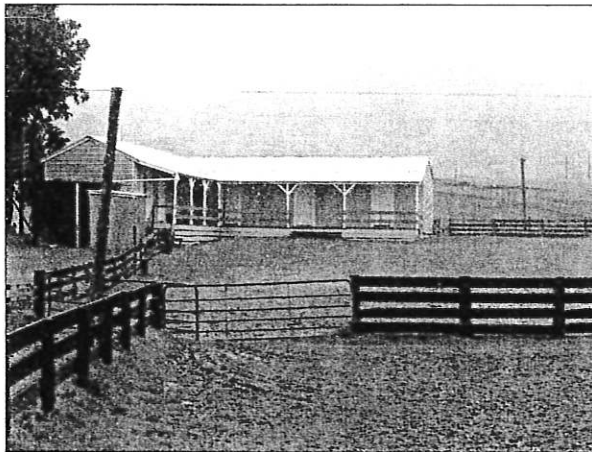
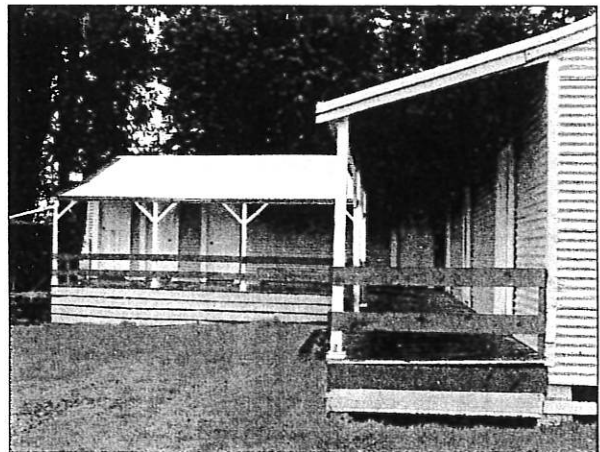
Shearer's Quarters

A large L shaped building with corrugated iron cladding and roof. There is wooden joinery.

Interior consists of 3 bedrooms (holes in one bedroom wall), Dining / Kitchen (S/S bench) area, Cooks Bedroom, Laundry (concrete tub) and 2 showers. Generally interior lined with hardboard with sheet Pinex ceilings.

Generally in Fair condition.

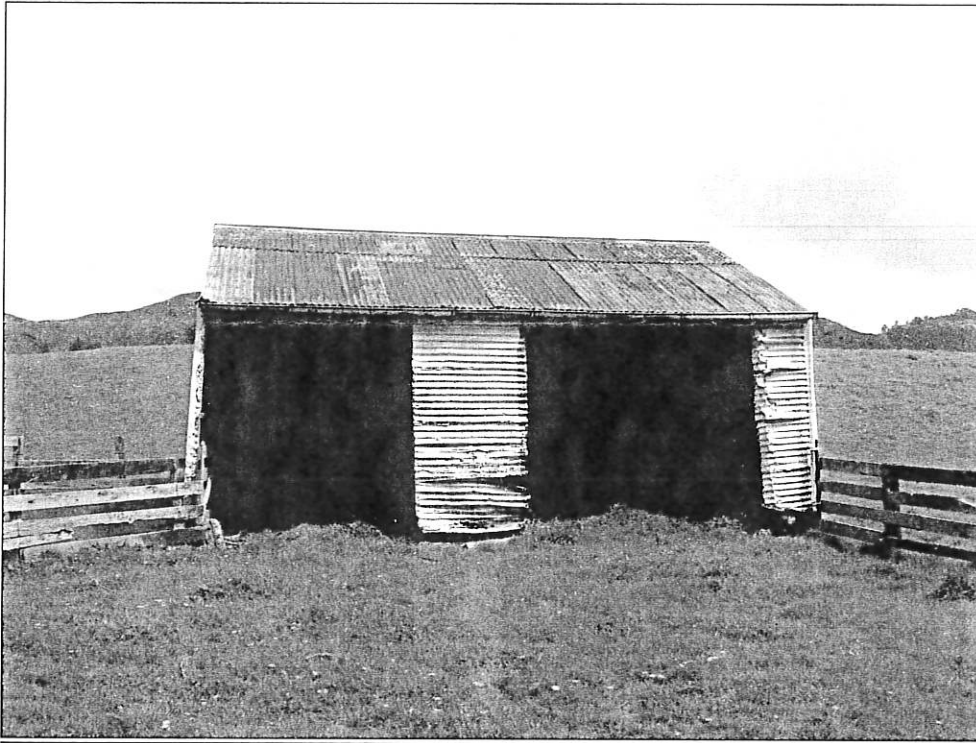
Shed

There is an implement shed on the side of the road which has corrugated iron roof and cladding three sides.

In generally fair / poor condition and needs repairs.

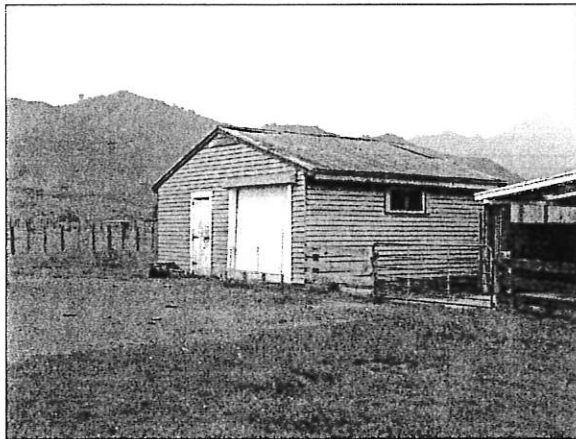
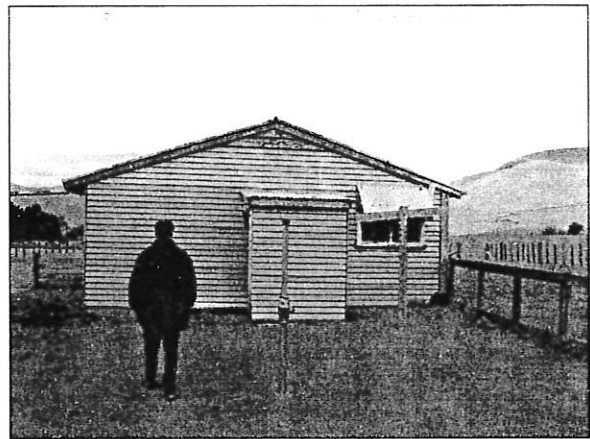
Garage

Sleepout partitioned on one corner with is lined with hardboard (damaged with lots of holes) and Sheet Pinex ceilings. Electric fittings damaged. Window missing.

Needs some repairs and a paint.

In fair condition only.

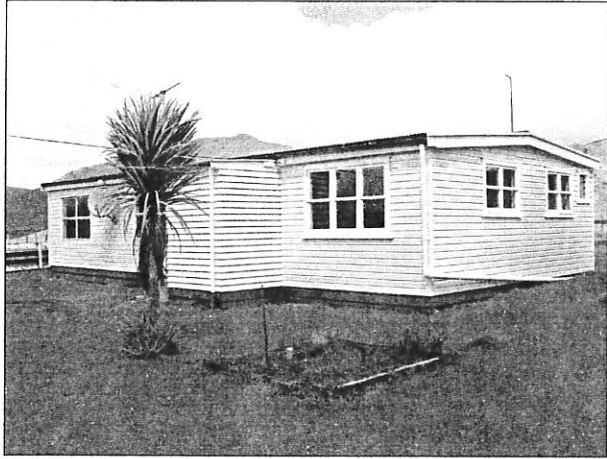
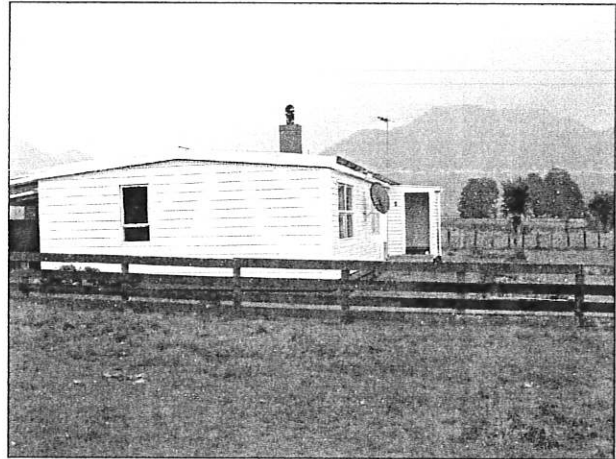
Dwelling (Rural number 133)

In fair condition, with the interior needing renovation / redecoration to bring up to a good standard.
